2009 Monitoring Summary

Hurricane Creek off Jackson County Road 9 (34.91799/-86.13300)

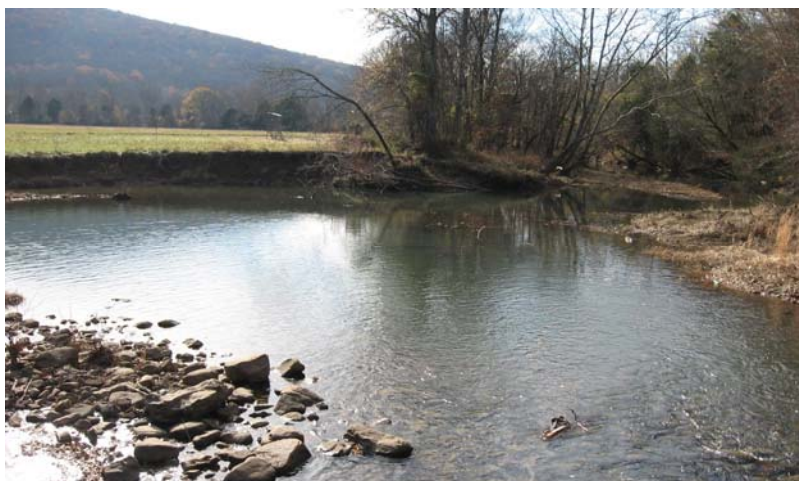
Figure 1. Hurricane Creek at HURR-1, December 3, 2008. Photo taken facing downstream.

General observations (Table 2) and a habitat assessment (Table 3) were completed during the macroinvertebrate assessment. In comparison with reference reaches in the same ecoregion, they give an indication of the physical condition of the site and the quality and availability of habitat. Hurricane Creek at HURR-1 is a high-gradient, mostly sand and gravel bottomed stream in the Tennessee River basin (Figure 1). Overall habitat quality was categorized as *optimal*, however most parameters fell into the *sub-optimal* category.

In October 2010, USFWS, and the Geological Survey of Alabama will conduct road and bridge crossing surveys to document impediments to fish movement. In 2011, TNC plans to remove the low head crossing at HURR-1 and replace with a low span bridge to allow upstream fish movement.
