2009 Monitoring Summary

Mill Branch at Franklin County Road 11 (34.53908/-88.10249)

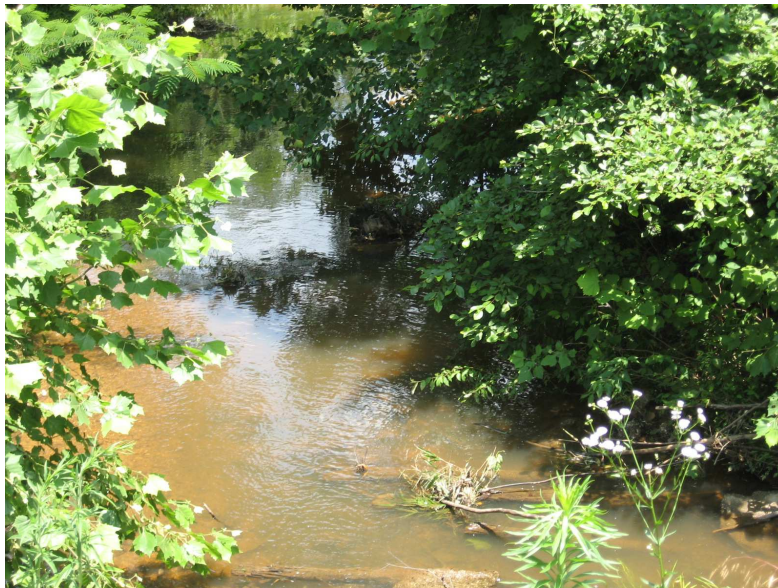
Figure 1. Mill Branch at MLBF-1, facing downstream.

General observations (Table 2) and a habitat assessment (Table 3) were completed during the macroinvertebrate assessment. In comparison with reference reaches in the same ecoregion, they give an indication of the physical condition of the site and the quality and availability of habitat. Mill Branch at MLBF-1 is a low-gradient, sand-bottomed stream lacking riffle habitat (Figure 1). Overall habitat quality was categorized as *sub-optimal*.
