2009 Monitoring Summary

§303(d)/TMDL Monitoring Site

Mud Creek at U.S. Hwy 31, Cullman County (34.05504/-86.76423)

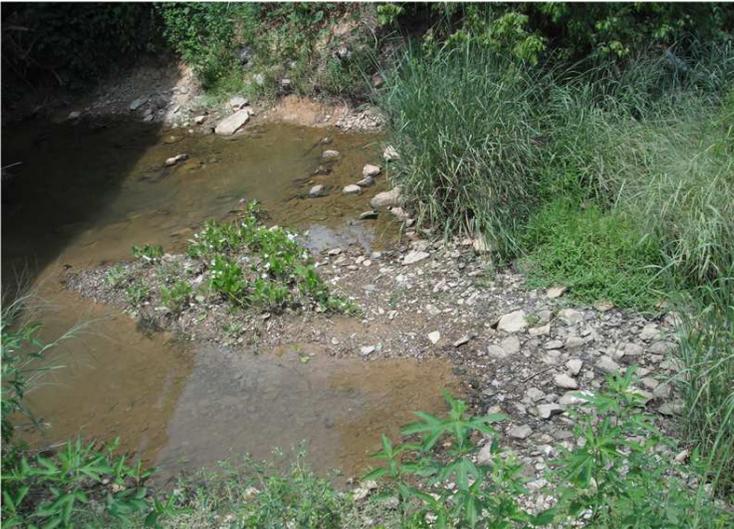
Figure 1. Reach Characteristics of Mud Creek at MUDC-2, August 6, 2010.

General observations (Table 2) and a habitat assessment (Table 3) were completed during the macroinvertebrate assessment. In comparison with reference reaches in the same ecoregion, they give an indication of the physical condition of the site and the quality and availability of habitat. Mud Creek at MUDC-2 is a small, open stream reach characterized by sand and clay substrates. Pools, deeper areas with lower velocities, comprised 100 percent of the available habitat (Figure 1). Overall habitat quality was categorized as *poor* due to excessive sedimentation, poor instream habitat quality and a narrow riparian buffer.
