2010 Monitoring Summary

Silver Creek in Clarke County (31.69517/-87.58156)

Additionally, Silver Creek was selected for biological and water quality monitoring as part of the 2010 Assessment of the Alabama, Coosa, and Tallapoosa River Basins. The objectives of the project were to assess the biological integrity of each monitoring site and to estimate overall water quality within the basin.

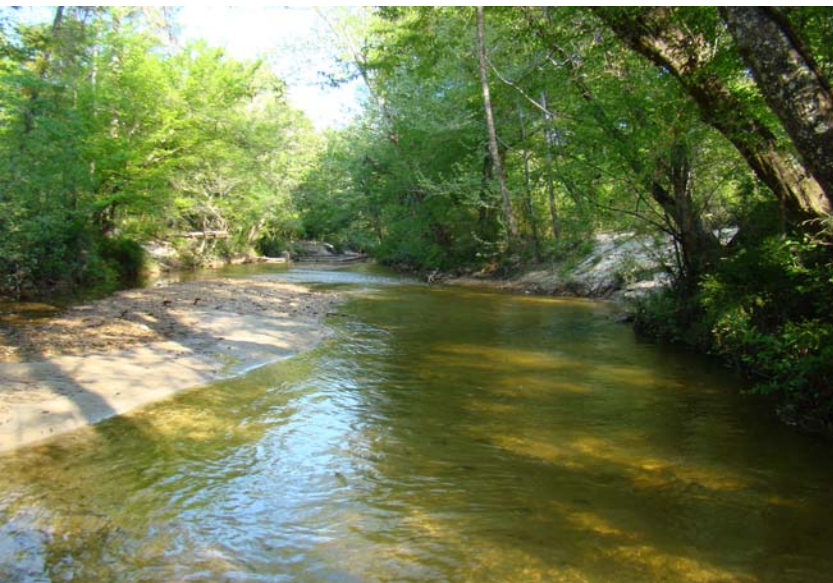
Figure 1. Silver Creek at SRC-1 April 15, 2010.

General observations (Table 2) and a habitat assessment (Table 3) were completed during the macroinvertebrate assessment. Silver Creek at SRC-1 (Figure 1) is a riffle-run stream characterized by sand and gravel substrates. Overall habitat quality was categorized as *sub-optimal*.
