# 2010 Monitoring Summary

Basin Assessment Site

## Sturdivant Creek at AL Hwy 10 in Wilcox County (31.83803/-86.90902)

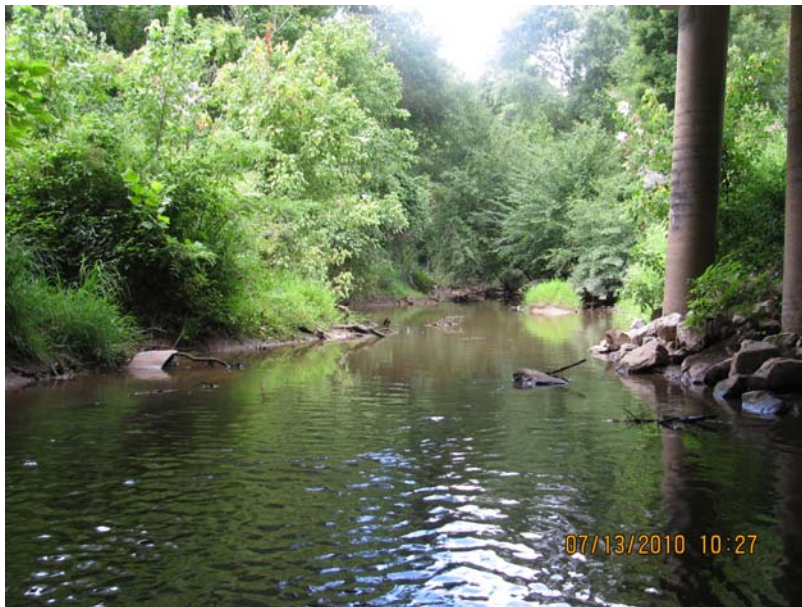
Figure 1. Sturdivant Creek at STVW-1, July, 13, 2010.

General observations (Table 2) and a habitat assessment (Table 3) were completed during the macroinvertebrate assessment. In comparison with reference reaches in the same ecoregion, they give an indication of the physical condition of the site and the quality and availability of habitat. Typical of ecoregion 65d, Sturdivant Creek at STVW-1 is a low gradient, sand bottomed stream (Figure 1). Overall habitat quality was categorized as *marginal* for supporting macroinvertebrate communities.
