2010 Monitoring Summary

Swift Creek at Chilton County Road 24 near Billingsley (32.72144/-86.69159)

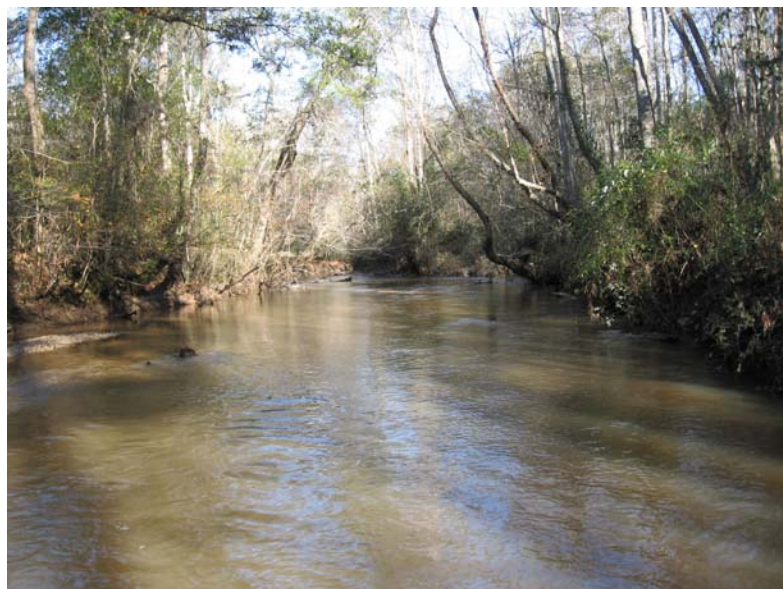
Figure 1. Swift Creek at SWFC-1, December 1, 2010.

General observations (Table 2) and a habitat assessment (Table 3) were completed during the macroinvertebrate assessment. In comparison with reference reaches in the same ecoregion, this information can give an indication of physical condition and the availability and quality of habitat. Swift Creek at SWFC-1 (Figure 1) is sand bottomed stream with small gravel riffles, leaf packs and snags that provide moderately stable habitat for biological communities. Overall habitat quality was categorized as *sub-optimal* for supporting macroinvertebrate communities.
