2010 Monitoring Summary

Unnamed Tributary to Dry Branch at Shelby County Road 103 (33.22680/-86.48350)

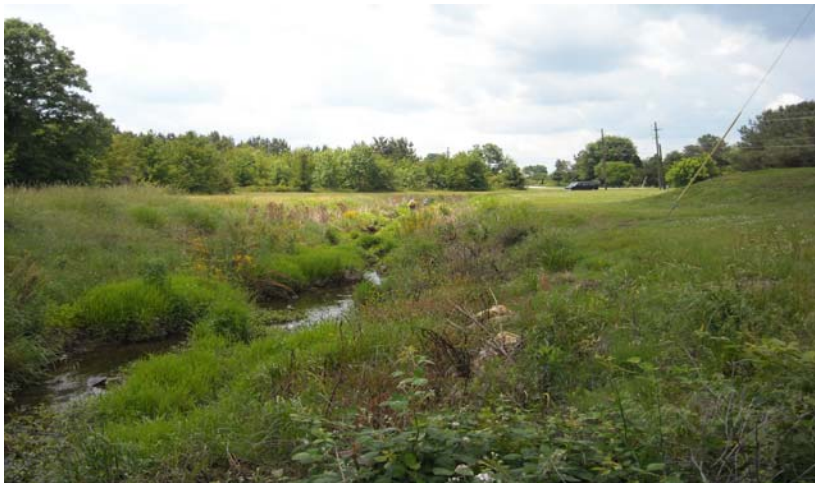
Figure 1. UT to Dry Branch at UTDS-1, May 18, 2010.

General observations (Table 2) and a habitat assessment (Table 3) were completed during the macroinvertebrate assessment. In comparison with reference reaches in the same ecoregion, they give an indication of the physical condition of the site and the quality and availability of habitat. The UT to Dry Branch at UTDS-1 is a small, open canopy stream reach characterized by gravel and cobble substrates (Figure 1). The lack of riparian protection combined with marginal ratings in both sediment deposition and sinuosity within the reach categorized the overall habitat quality as *marginal* for supporting macroinvertebrate communities.
