2011 Monitoring Summary

Coal Fire Creek on Water Mill Road in Pickens County (33.49180/-88.01386)

The Alabama Department of Environmental Management (ADEM) selected the Coal Fire Creek watershed for biological and water quality monitoring as part of the 2011 Escatawpa, Mobile, and Tombigbee (EMT) River Basin Assessments. The objectives of the project were to assess the biological integrity of each monitoring site and to estimate overall water quality within these basins.

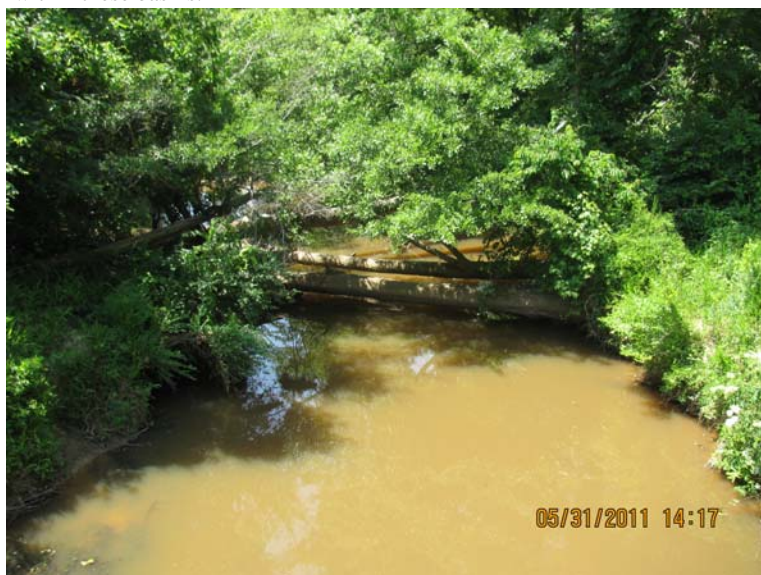
Figure 1. Coal Fire Creek at CLFP-13.

General observations (Table 2) and a habitat assessment (Table 3) were completed during the macroinvertebrate assessment. In comparison with reference reaches in the same ecoregion, they give an indication of the physical condition of the site and the quality and availability of habitat. Coal Fire Creek at CLFP-13 is a low-gradient, glide-pool stream in the Fall Line Hills sub-ecoregion, with substrate composed primarily of sand and clay (Figure 1). The high percentage of clay substrate is unusual for streams in this sub-ecoregion, which are generally characterized by small gravel riffles and sand substrates. The reach was characterized by limited instream habitat and a relatively straight stream channel. Water quality samples were collected from the bridge, where the stream was non-wadeable and velocity was slow. However, upstream where the bioassessment was conducted, the CLFP-13 became narrow and shallow. Tables 2 and 3 reflect conditions where the bioassessment was conducted.

Overall habitat quality in Coal Fire Creek at CLFP-13 was categorized as *sub-optimal* due to poor instream habitat quality and stream sinuosity. The reach was also characterized by a high percentage of clay substrates, which is atypical of streams in ecoregion 65i. Bioassessment results indicated the macroinvertebrate community to be in *poor* condition. Monitoring should continue at CLFP-13 to ensure that biological and water quality conditions remain stable.
