2011 Monitoring Summary

Kinterbish Creek at Sumter County Road 9 (32.34627/-88.26527)

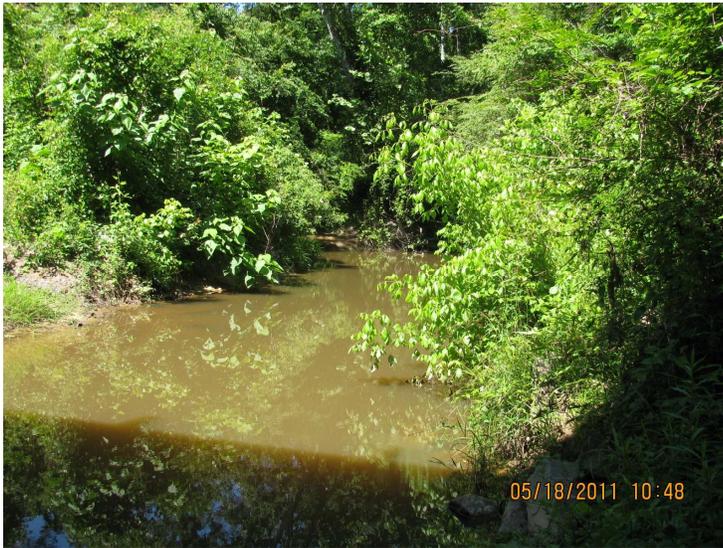
Figure 1. Kinterbish Creek at KNBS-1, May 18, 2011.

General observations (Table 2) and a habitat assessment (Table 3) were completed during the macroinvertebrate assessment. In comparison with reference reaches in the same ecoregion, they give an indication of the physical condition of the site and the quality and availability of habitat. Kinterbish Creek at KNBS-1 is a low-gradient, glide-pool stream with substrate composed primarily of sand (Figure 1). The reach was characterized by limited root bank habitat and a relatively straight stream channel.

Bioassessment results indicated the macroinvertebrate community to be in *good* condition. Overall habitat quality was categorized as *sub-optimal* due to a marginal stream sinuosity and bank and vegetative stability. Monitoring should continue to ensure that biological and water quality conditions remain stable.
