2012 Monitoring Summary

Blevens Creek at Cullman County Road 1059 (34.26740/-87.07760)

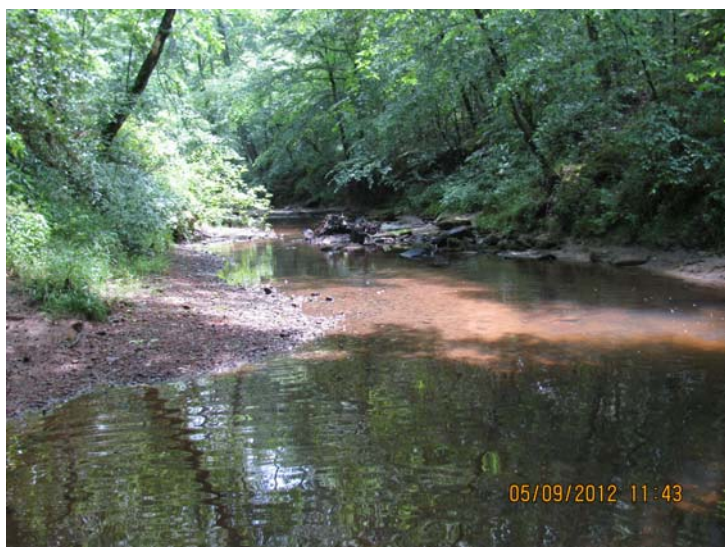
Figure 1. Blevens Creek at BLVC-1, May 9, 2012.

General observations (Table 2) and a habitat assessment (Table 3) were completed during the macroinvertebrate assessment. In comparison with reference reaches in the same ecoregion, they give an indication of the physical condition of the site and the quality and availability of habitat. Blevens Creek at BLVC-1 is a high-gradient, riffle-run stream characterized mostly by bedrock and gravel (Figure 1). Overall habitat quality was rated as *optimal* for supporting macroinvertebrate communities.
