# 2012 Monitoring Summary

## Buck Creek below dam off Hwy 261 (Shelby County) (33.29694/-86.84263)

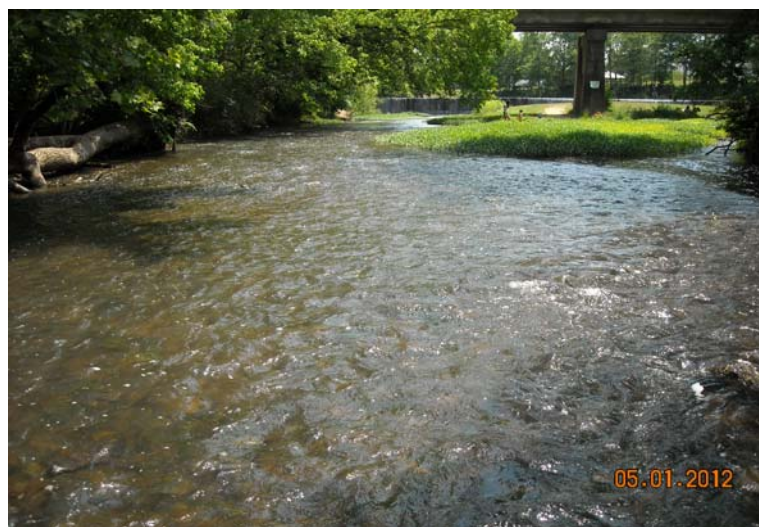
Figure 1. Buck Creek at B-1, May 1, 2012.

Watershed characteristics are summarized in Table 1. Buck Creek at B-1 is a *Fish & Wildlife (F&W)* stream located in the Southern Limestone/Dolomite Valleys and Low Rolling Hills sub-ecoregion (67f) of the Ridge and Valley ecoregion (67) in Shelby County (Figure 1). Based on the 2006 National Land Cover Dataset, land cover within the watershed is approximately 52% forested. As of September 1, 2012, ADEM's NPDES Management System database shows 342 permitted discharges located within the watershed, the majority of which are construction stormwater permits.

General observations (Table 2) and a habitat assessment (Table 3) were completed during the macroinvertebrate assessment. In comparison with reference reaches in the same ecoregion, they give an indication of the physical condition of the site and the quality and availability of habitat. Buck Creek at B-1 is a high-gradient, riffle-run stream characterized by gravel and cobble substrates. Overall habitat quality was categorized as *sub-optimal* for supporting macroinvertebrate communities (Table 3). Sinuosity and riparian buffer were issues within the reach.
