2012 Monitoring Summary

Cane Creek at AL Highway 69 near Oakman (Walker County) (33.70939/-87.39071)

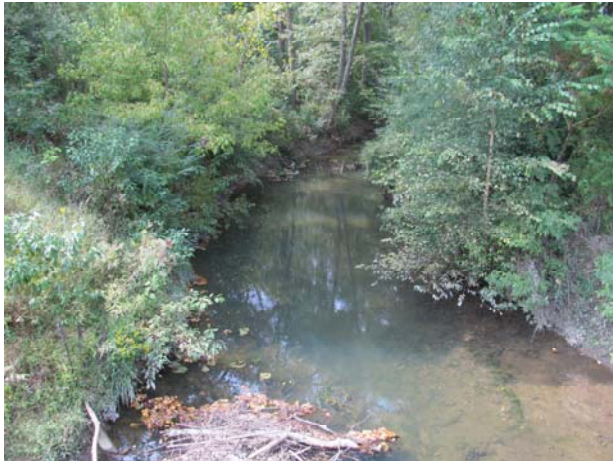
Figure 1. Cane Creek at CANW-33 October 3, 2012.

General observations (Table 2) and a habitat assessment (Table 3) were completed during the macroinvertebrate assessment. In comparison with reference reaches in the same ecoregion, they give an indication of the physical condition of the site and the quality and availability of habitat. Cane Creek at CANW-33 is a glide-pool stream located in the Shale Hills ecoregion (68f) (Figure 1). Benthic substrate consists primarily of sand with some gravel and clay. Overall habitat quality was rated as *sub-optimal* for supporting a diverse biological community.
