2012 Monitoring Summary

Turkey Creek at Jefferson County Road 131 (33.72924/-86.73975)

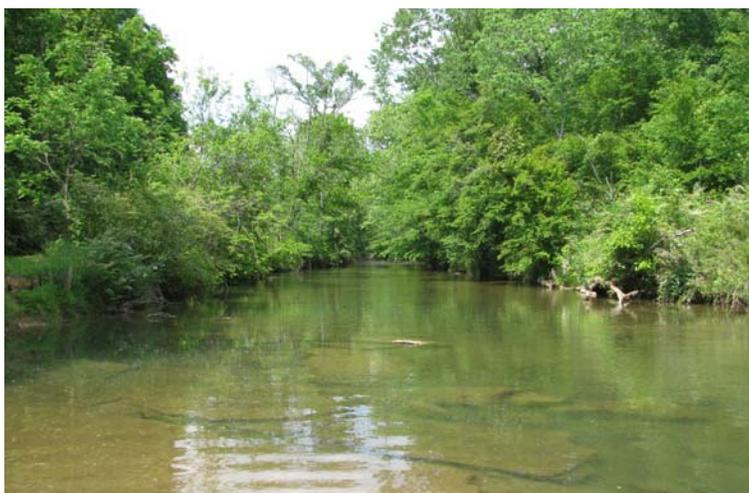
Figure 1. Turkey Creek at TRKJ-2A on May 1, 2012.

General observations (Table 2) and a habitat assessment (Table 3) were completed during the macroinvertebrate assessment. In comparison with reference reaches in the same ecoregion, they give an indication of the physical condition of the site and the quality and availability of habitat. Turkey Creek at TRKJ-2A is a riffle-run stream characterized primarily by bedrock (Figure 1). Overall habitat quality was categorized as *optimal*.
