2013 Monitoring Summary

Cedar Creek at Alabama Highway 43 in Franklin County (34.46472/-87.75306)

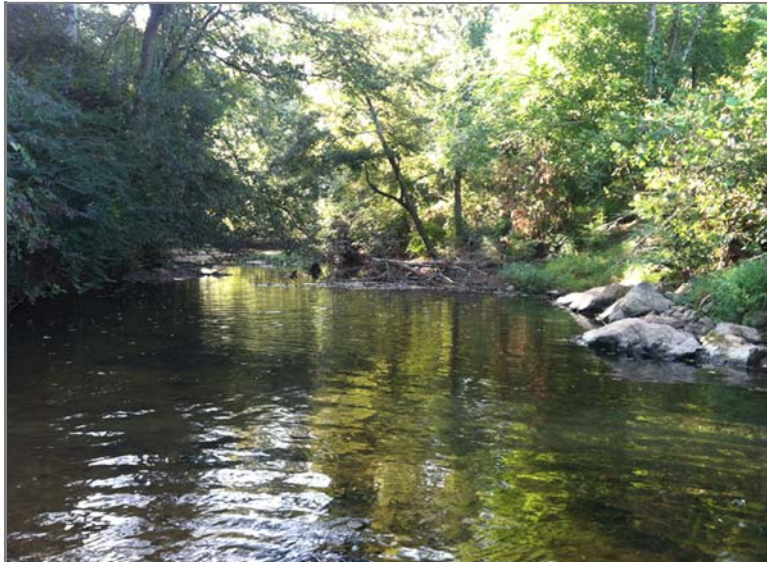
Figure 1. Cedar Creek at CDRF-5, September 19, 2013.

General observations (Table 2) and a habitat assessment (Table 3) were completed during the macroinvertebrate assessment. In comparison with reference reaches in the same ecoregion, they give an indication of the physical condition of the site and the quality and availability of habitat. Cedar Creek at CDRF-5 is characterized primarily by sand and gravel substrates (Figure 1). Overall habitat quality was categorized as *marginal* for this stream type.

Bioassessment results indicated the macroinvertebrate community to be in *fair* condition. However, overall habitat quality for Cedar Creek at CDRF-5 was categorized as *marginal* for this stream type. Several water parameters were higher than expected based on data collected at reference reaches within the Interior Plateau ecoregion. Monitoring should continue to ensure that conditions remain stable.
