2014 Monitoring Summary

Buckhorn Creek at US Highway 29, Pike County (31.84217/-85.75905)

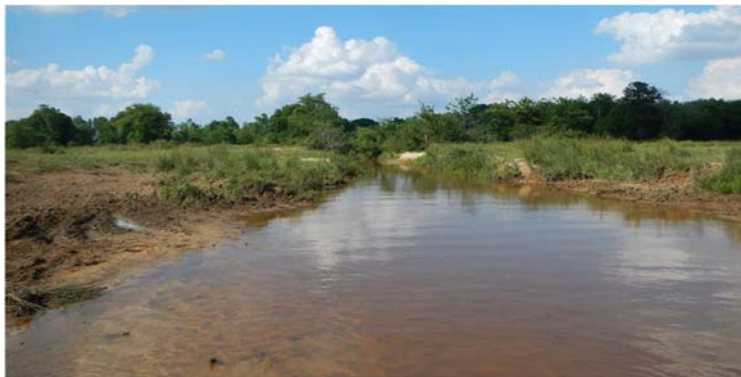
Figure 1. Buckhorn Creek at BKHP-2, March 13, 2014.

General observations (Table 2) and a habitat assessment (Table 3) were completed during the macroinvertebrate assessment. In comparison with reference reaches in the same ecoregion, they give an indication of the physical condition of the site and the quality and availability of habitat. Buckhorn Creek at BKHP-2 is characterized by a sandy substrates, unstable banks, and very limited riparian vegetation and shading (Figure 1). Overall habitat quality was categorized as *marginal*.
