Patrick Creek at Coffee County Road 368 (31.43840/-86.11210)

The Alabama Department of Environmental Management (ADEM) selected the Patrick Creek watershed for biological and water quality monitoring as part of the 2014 Survey of the Southeastern Alabama River Basins. The objectives of these surveys were to fully assess biological, chemical, and physical conditions within the watershed.

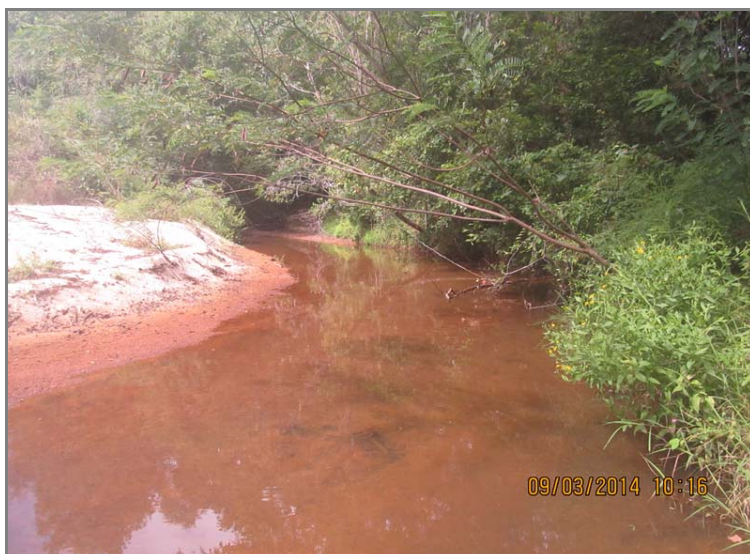
Figure 1. Patrick Creek at PATC-1, September 3, 2014.

General observations (Table 2) and a habitat assessment (Table 3) were completed during the assessment. In comparison with reference reaches in the same ecoregion, they give an indication of the physical condition of the site and the quality and availability of habitat. Patrick Creek at PATC-1 is sand-bottomed, glide-pool stream, typical of creeks in the 65d ecoregion (Figure 1). Overall habitat quality was categorized as *sub-optimal* due to limited instream habitat.
