# 2014 Monitoring Summary

## Patsaliga Creek at Pike County Road 30 (31.83190, -86.18314)

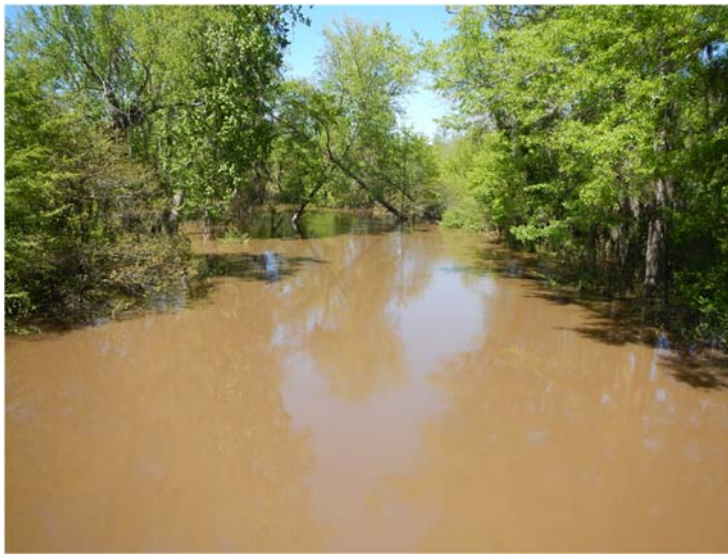
Figure 1. Patsaliga Creek at PSGP-1, April 16, 2014.

General observations (Table 2) and a habitat assessment (Table 3) were completed during the fish community assessment. In comparison with reference reaches in the same ecoregion, they give an indication of the physical condition of the site and the quality and availability of habitat. Patsaliga Creek at PSGP-1 is a relatively deep, slow moving reach, characterized by organic matter, mud/muck, and silt substrates (Figure 1). Overall habitat quality and availability was rated as *sub-optimal* for supporting diverse aquatic communities mainly due to high sediment deposition and marginal vegetative stability.
