Basin Assessment Site

2015 Monitoring Summary

Bughall Creek at Bullock County Road 177 (32.16144/-85.83485)

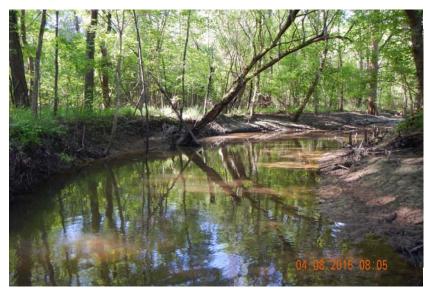
Figure 1. Bughall Creek at BGHM-1, April 8, 2015.

General observations (Table 2) and a habitat assessment (Table 3) were completed during the macroinvertebrate assessment. In comparison with reference reaches in the same ecoregion, they give an indication of the physical condition of the site and the quality and availability of habitat. Bughall Creek at BGHM-1 is a light tannic, mostly-shaded, glide-pool stream (Figure 1). Benthic substrate in the reach consists primarily of sand, with some silt and snags/woody debris. Water levels were low, exposing much of the rootbank habitat throughout the reach. Overall habitat quality was rated as *marginal* for supporting macroinvertebrate communities.
