# 2015 Monitoring Summary

## Capsey Creek at unnamed Winston County road (Forest Service 266) (34.26957/-87.21056)

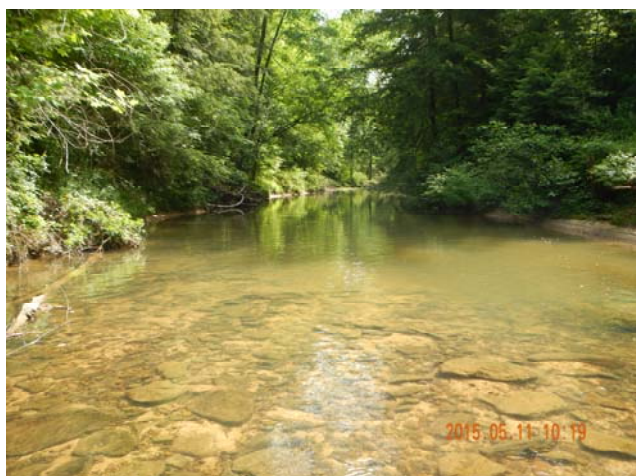
Figure 1. Capsey Creek at CPSY-1, May 11, 2015.

Watershed characteristics are summarized in Table 1. Capsey Creek (Figure 1) is a *Fish & Wildlife (F&W)* tributary of the Black Warrior River in the Dissected Plateau ecoregion. This ecoregion is a rugged, hilly, moderately to strongly dissected plateau containing some steep-sided gorge-like valleys and moderate to high gradient streams with bedrock and boulder substrates. Based on the 2011 National Land Cover Dataset, eighty-seven percent of landuse within the watershed is forested and entirely within Bankhead National Forest. There are no NPDES outfalls located within the watershed.
