# 2016 Monitoring Summary

## Butler Creek at Lauderdale County Road 302 (34.97375/-87.61126)

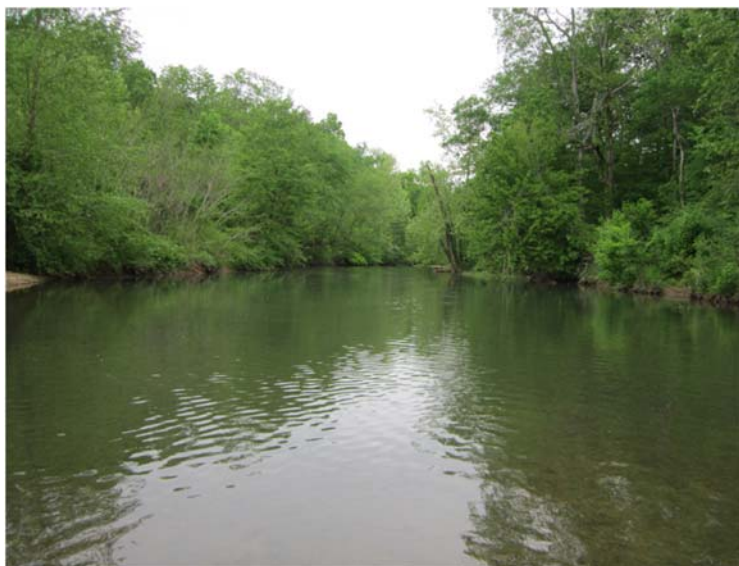
Figure 1. Pool habitat in Butler Creek at BTLL-1, May 1, 2019.

General observations (Figure 1, Table 2) and a habitat survey (Table 3) were completed during the Index of Biotic Integrity (AL-IBI) fish community survey. In comparison with reference reaches in the same ecoregion, they give an indication of the physical condition of the site and the quality and availability of habitat. Like other streams in ecoregion 71F, Butler Creek at BTLL-1 is characterized by gravel, cobble and bedrock substrates. The 900 ft stream reach is wide, with a mostly-open canopy, and long riffle/run complexes separating shallow pools. Overall habitat quality and availability was rated as *optimal* for supporting fish and other aquatic communities.
