2016 Monitoring Summary

Use Support Assessment

Cypress Creek at Alabama Highway 133/Cox Creek Parkway (Lauderdale County) (34.83055/-87.70418)

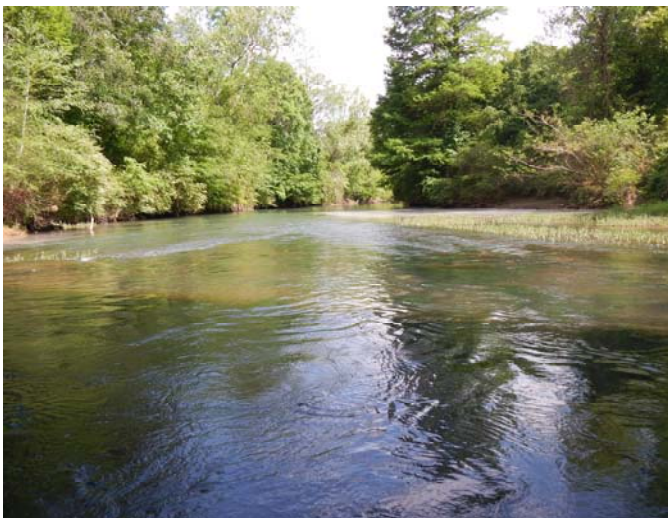
Figure 1. Cypress Creek at CPSL-3, May 2, 2016.

General observations (Figure 1, Table 2) and a habitat survey (Table 3) were completed during the fish community survey. In comparison with reference reaches in the same ecoregion, they give an indication of the physical condition of the site and the quality and availability of habitat. Cypress Creek, at CPSL-3, is predominantly run habitat and cobble-gravel substrates. Overall habitat quality and availability have been rated as *optimal* for supporting biological communities (Table 3).
