# 2016 Monitoring Summary

## Emuckfaw Creek at Bill Price Road in Tallapoosa County (33.05530/-85.69460)

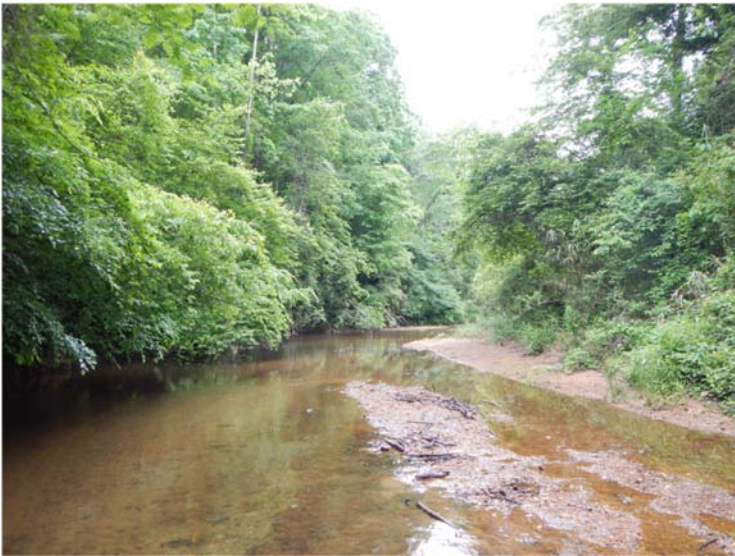
Figure 1. Emuckfaw Creek at EMKT-14, May 18, 2016.

General observations (Figure 1, Table 2) and a habitat survey (Table 3) were completed during the macroinvertebrate survey. In comparison with reference reaches in the same ecoregion, they give an indication of the physical condition of the site, and the quality and availability of habitat. Emuckfaw Creek at EMKT-14 is characterized by a predominantly sand substrate with some gravel. Overall habitat quality and availability has been rated as *sub-optimal* for supporting the macroinvertebrate communities.

The ADEM monitors Emuckfaw Creek at EMKT-14 as a reference reach for comparison with other Southern Inner Piedmont streams. Emuckfaw Creek at EMKT-14 is sand-bottomed stream with small gravel riffles, typical of streams in the region.

The macroinvertebrate community was rated as *good-excellent*, with high diversity and taxa richness within the reach. However, the dissolved iron concentration was higher than expected for this ecoregion. Monitoring should continue to ensure that conditions remain stable.
