# 2019 Monitoring Summary

**Beaverdam Creek** at Mt. Lebanon Rd in Madison County (34.87421/-86.60704)

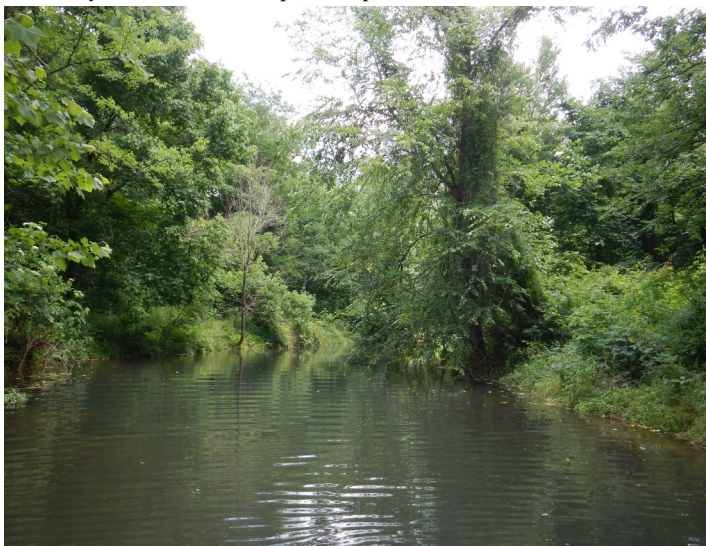
**Figure 1.** Beaverdam Creek at BVDM-1, May 28, 2019.

General observations (Table 2) and a habitat survey (Table 3) were completed during the macroinvertebrate assessment. In comparison with reference reaches in the same ecoregion, they give an indication of the physical condition of the site and the quality and availability of habitat. Beaverdam Creek at BVDM-1 (Figure 1) is a low-gradient, cobble and gravel bottomed stream. Habitat quality and availability was rated as *fair* for supporting diverse aquatic macroinvertebrate communities due to sediment deposition and lack of sinuosity.

Bioassessment results indicated the macroinvertebrate community to be in *fair-poor* condition. Overall habitat quality was categorized as *fair* for supporting diverse aquatic macroinvertebrate communities due to sediment deposition and lack of sinuosity. Results from water quality sampling indicated that median nitrate-nitrite nitrogen, total nitrogen and chloride values were higher than the median concentration of all verified ecoregional reference reach data collected in ecoregion 71g. Values for pH and ammonia nitrogen were >90% of all verified ecoregional reference reach data collected in the ecoregion 71g. Monitoring should continue to ensure that water quality and biological conditions remain stable.
