# 2019 Monitoring Summary

## Ecological Reference Reach

### Hatchet Creek at County Road 4 in Clay County (33.13045/-86.05469)

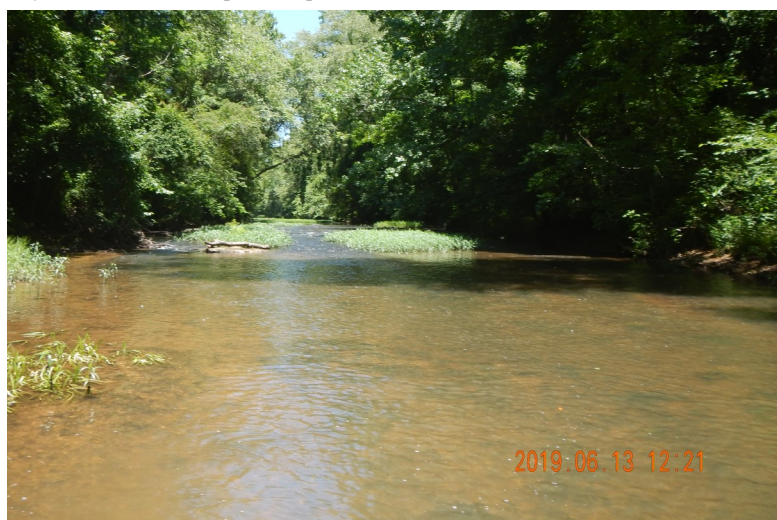
**Figure 1.** Hatchet Creek at HAT-3, June 13, 2019.

General observations (Table 2) and a habitat survey (Table 3) were completed during the fish IBI assessment. In comparison with reference reaches in the same ecoregion, they give an indication of the physical condition of the site and the quality and availability of habitat. Hatchet Creek at HAT-3 (Figure 1) is a low to moderate gradient stream characterized predominantly by bedrock, boulder, and cobble substrate. Hatchet Creek consists of mostly runs, with limited percentages of riffles and pools within this reach. Overall habitat quality was categorized as *good* for supporting the biological communities in this stream type due to the lack of multiple layers of stable riffle substrate and a balance of velocity/depth regimes within the reach.
