# 2019 Monitoring Summary

## Ecological Reference Reach

Hatchet Creek approximately 4 miles upstream of Coosa County Road 18 (32.94392/-86.23579)

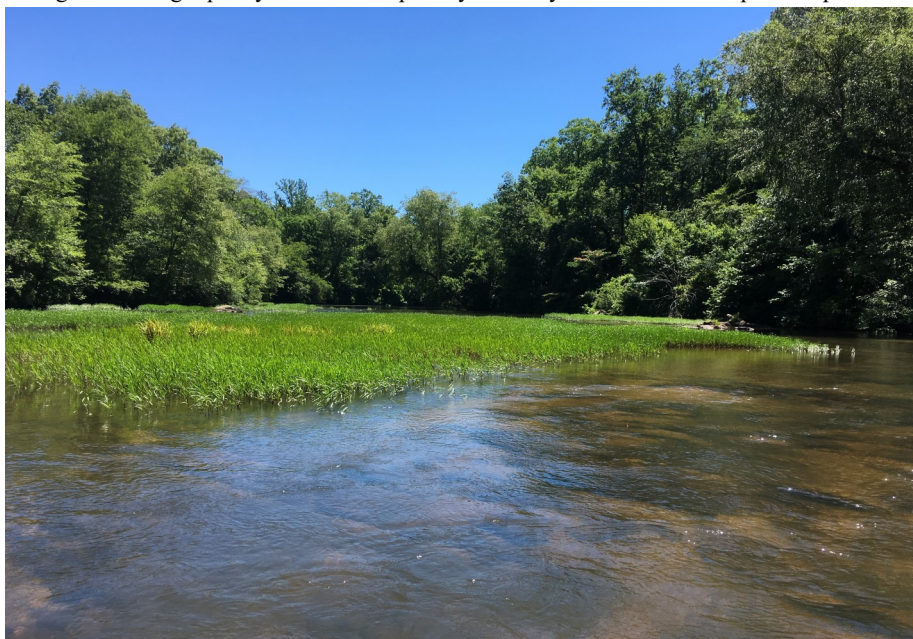
Figure 1. Hatchet Creek at HATC-4, June 8, 2019.

General observations (Figure 1, Table 2) and a habitat survey (Table 3) were completed during the fish community assessment. In comparison with reference reaches in the same ecoregion, they give an indication of the physical condition of the site and the quality and availability of habitat. Like other streams in ecoregion 45a, Hatchet Creek at HATC-4 is a medium-high gradient stream characterized predominantly by a bedrock, cobble and gravel substrate. Overall habitat quality was categorized as *sub-optimal/optimal* for supporting the biological communities in this stream type.
