# 2019 Monitoring Summary

**Joe's Branch** at I-10 westbound off ramp (Exit 35) in Baldwin County. (30.65702/-87.909054)

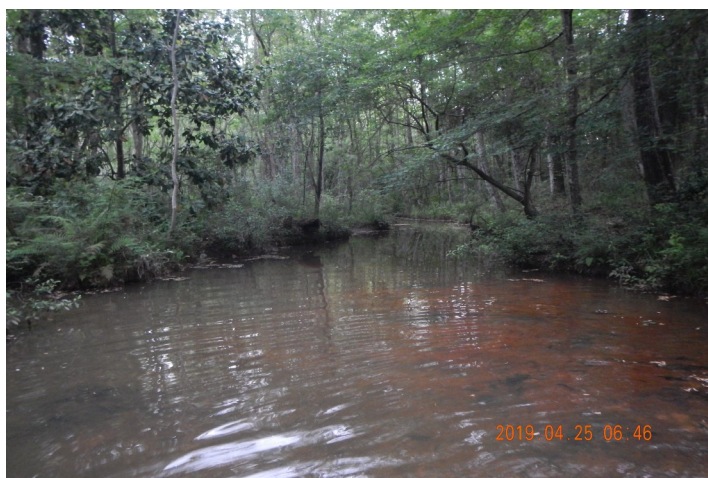
**Figure 1.** Joe's Branch at JOBB-2, April 25, 2019.

General observations (Table 2) and a habitat survey (Table 3) were completed during the macroinvertebrate assessment. In comparison with reference reaches in the same ecoregion, they give an indication of the physical condition of the site and the quality and availability of habitat. Joe's Branch at JOBB-2 (Figure 1) is a low-gradient, sand-bottomed stream. Habitat quality and availability was rated as *marginal/sub-optimal* for supporting diverse aquatic macroinvertebrate communities due to sediment deposition and channelization.
